# ROCKVILLE SWIM AND FITNESS CENTER LOCKER ROOMS & LOBBY RENOVATIONS & ADDITIONS JUNE 22, 2017 | PUBLIC INPUT MEETING

## PROJECT HISTORY

## PROJECT SCOPE

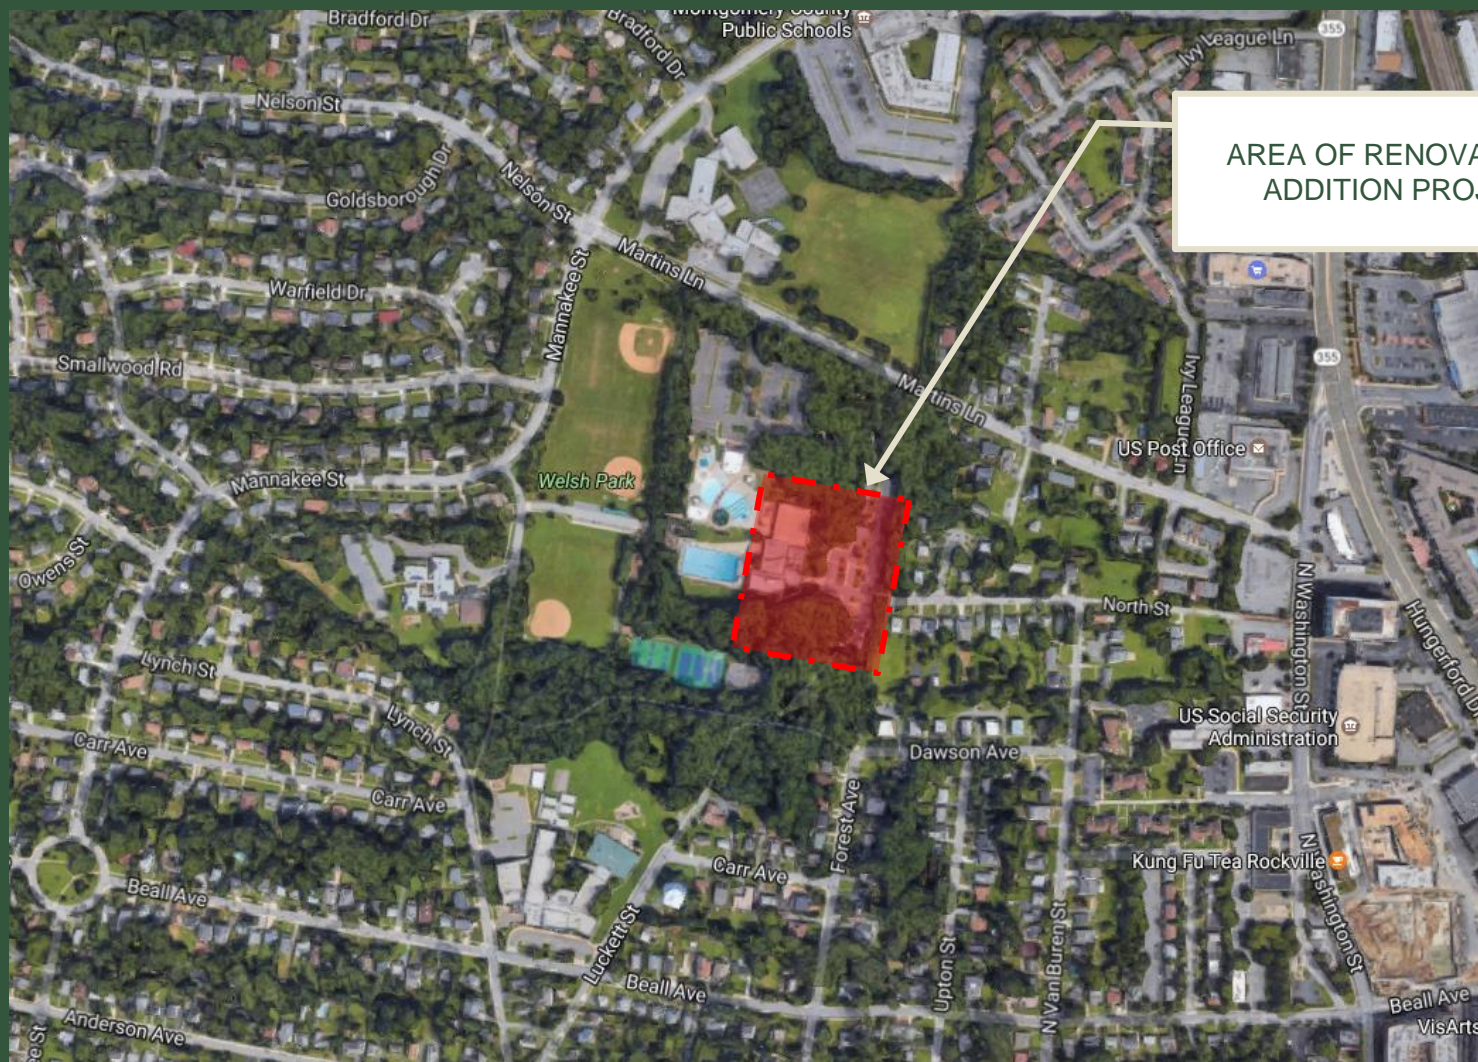
AERIAL  
VICINITY  
PHOTO

AREA OF RENOVATION &  
ADDITION PROJECT

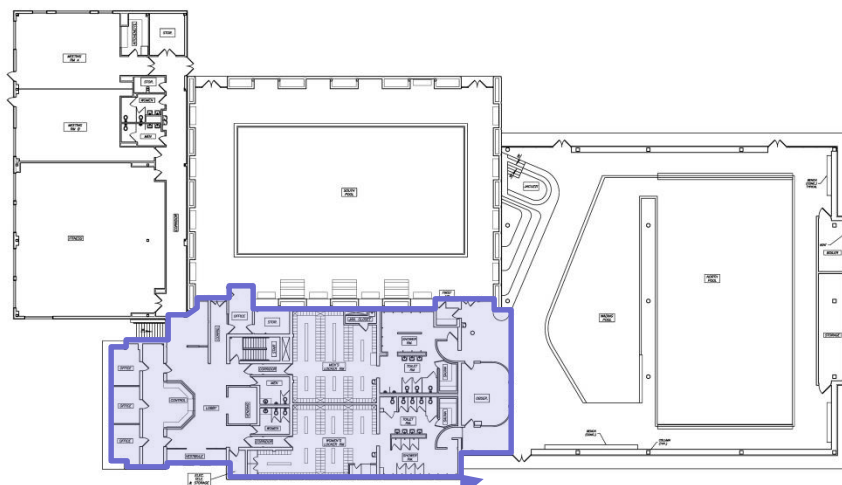
EXISTING  
BUILDING  
FLOOR PLAN

AREA OF RENOVATION

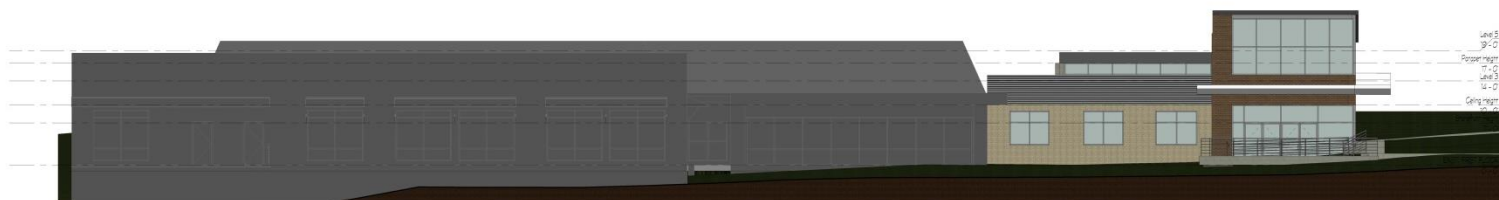
1 SOUTH ELEVATION PRESENTATION  
A3.0 1/8" = 1'-0"

(VISIBLE FROM INDOOR FACILITY PARKING LOT)

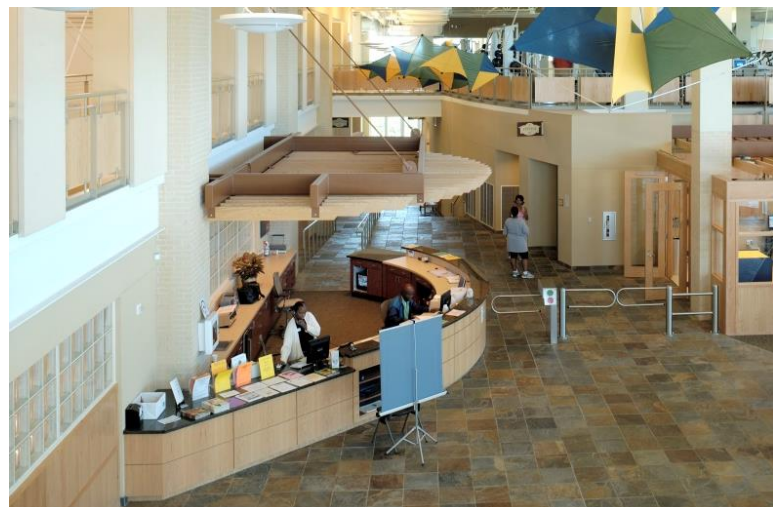
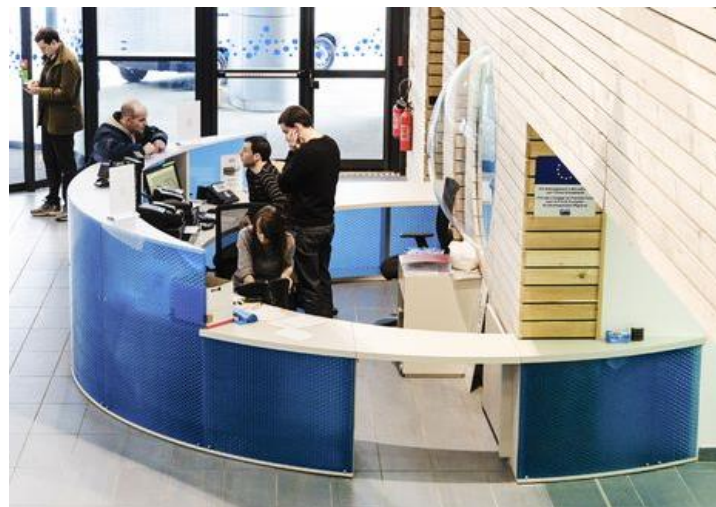
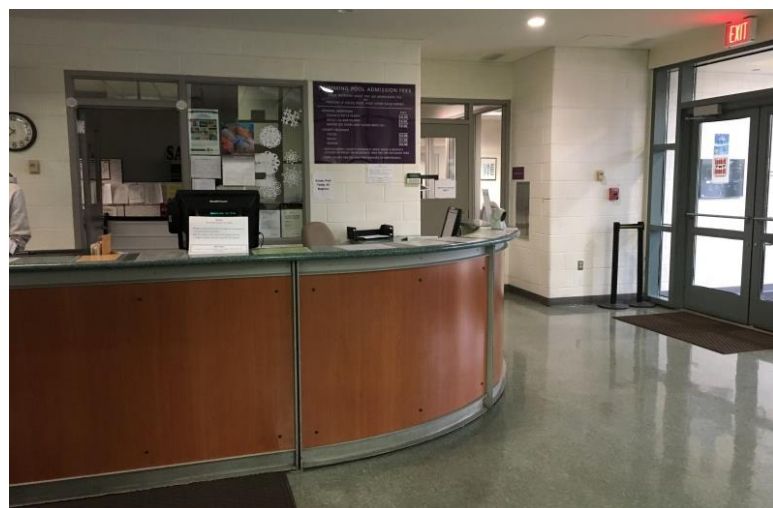
Reception Desk & Lobby

- Improved circulation & security
- Natural daylight
- Improved Traffic Flow
- Acoustic Controls

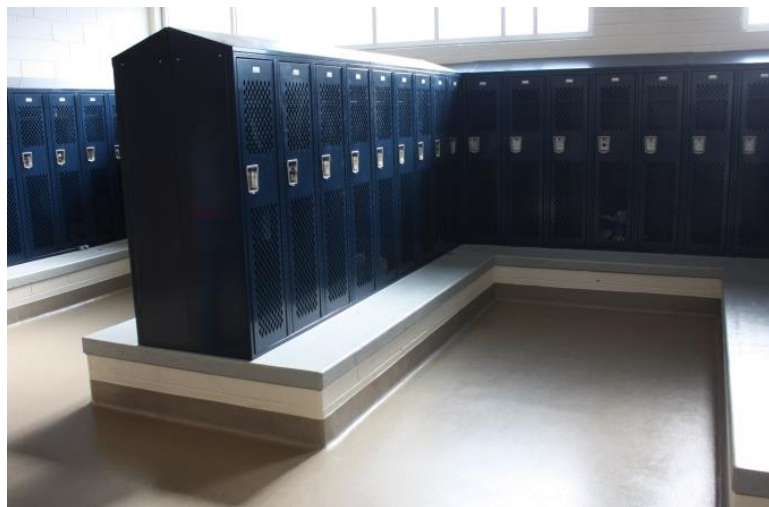
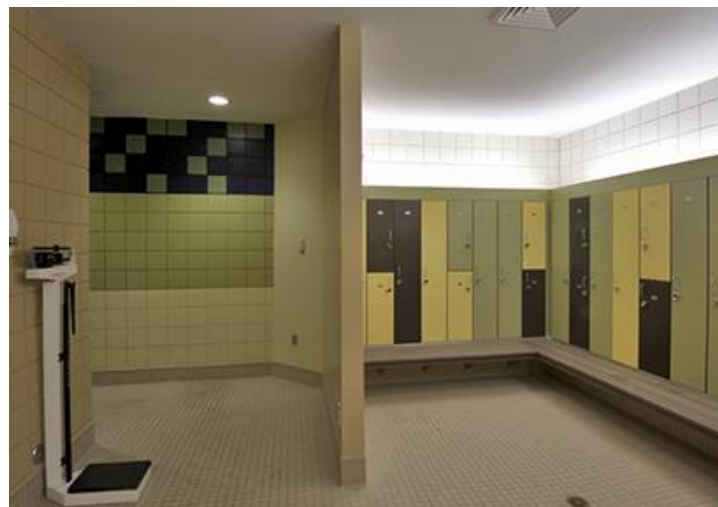
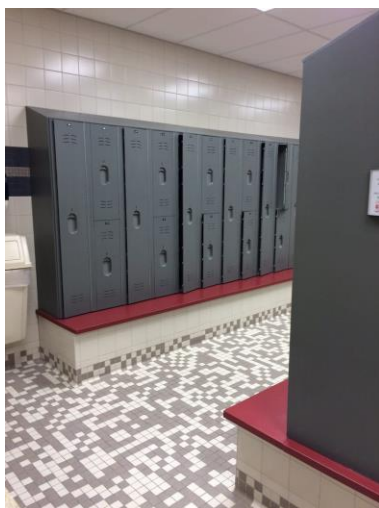
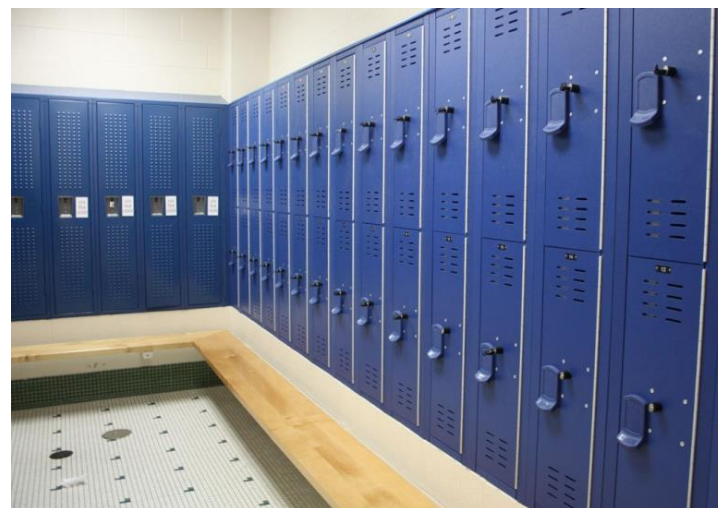
Lockers and Benches

- Built-in benches in front of lockers
- Mix of locker sizes
- Durable lockers, either plastic or phenolic

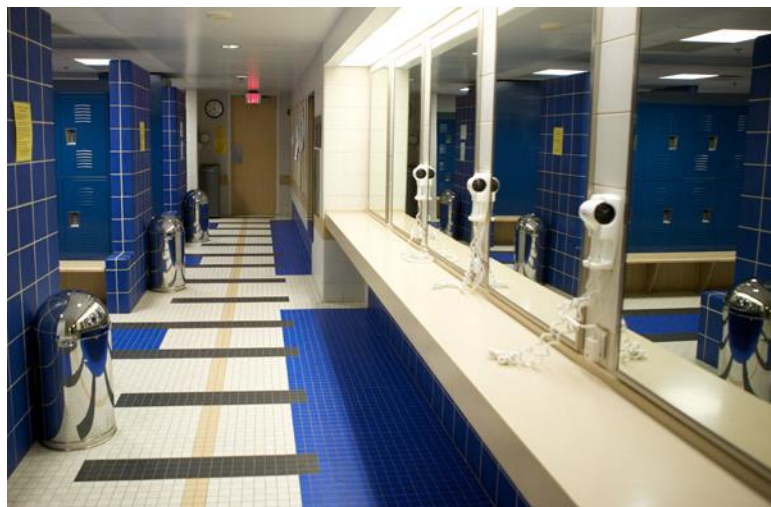
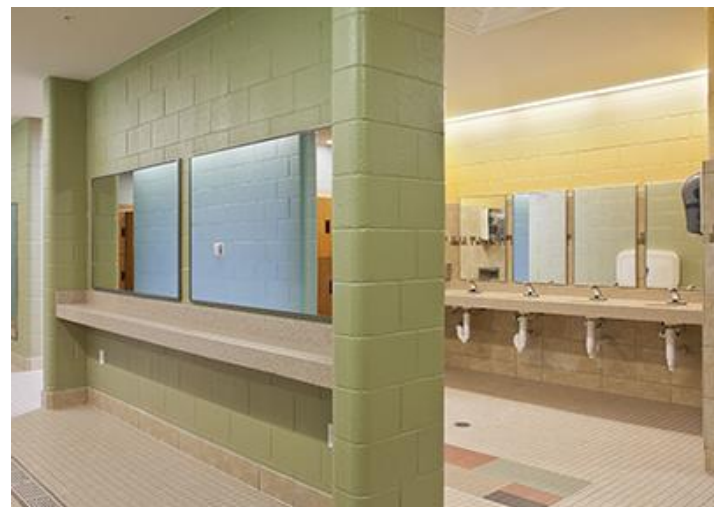
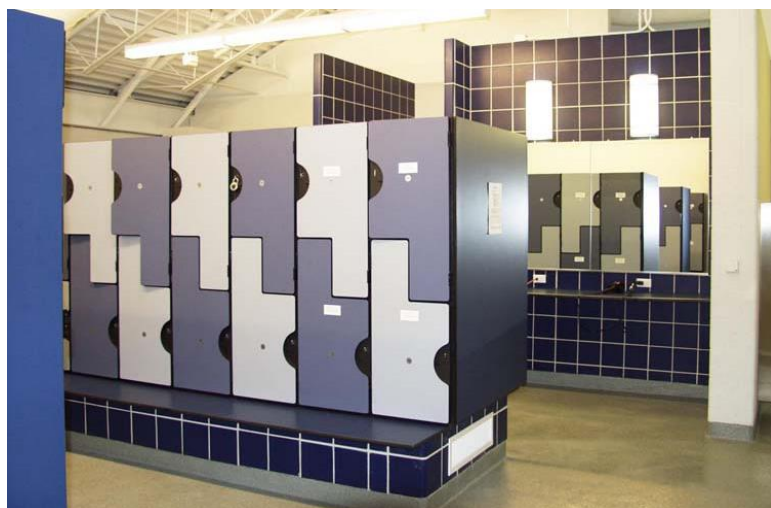
Grooming Stations

- Countertop area with mirrors
- Separate from sink area
- Outlets for hair dryers, etc.

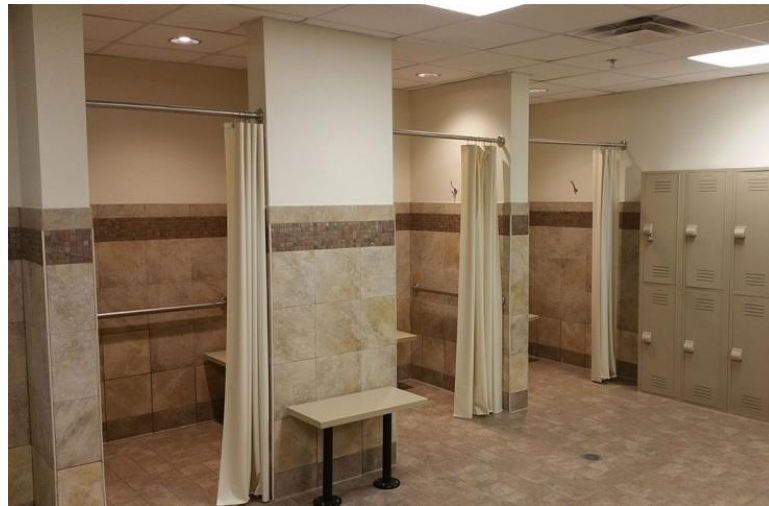
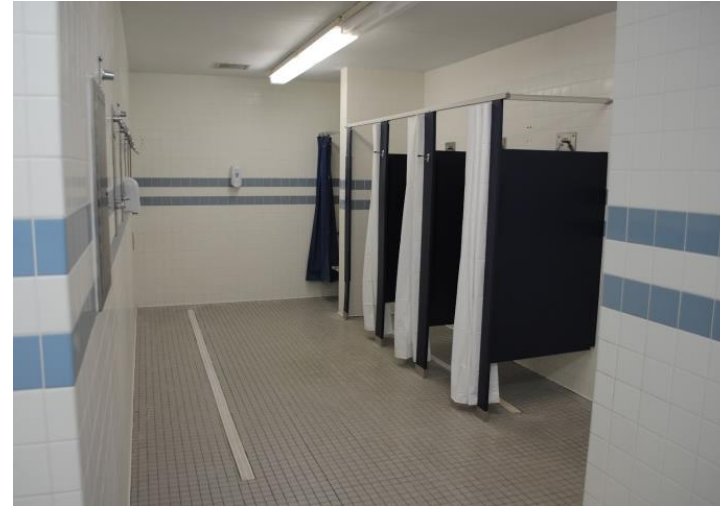
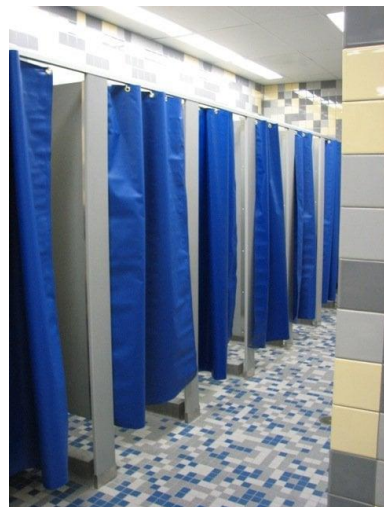
Private Showers and  
Changing Stalls

- Divider partitions with curtains
- Well-lit and inviting
- Durable, easy-to-clean, non-slip ceramic tile flooring

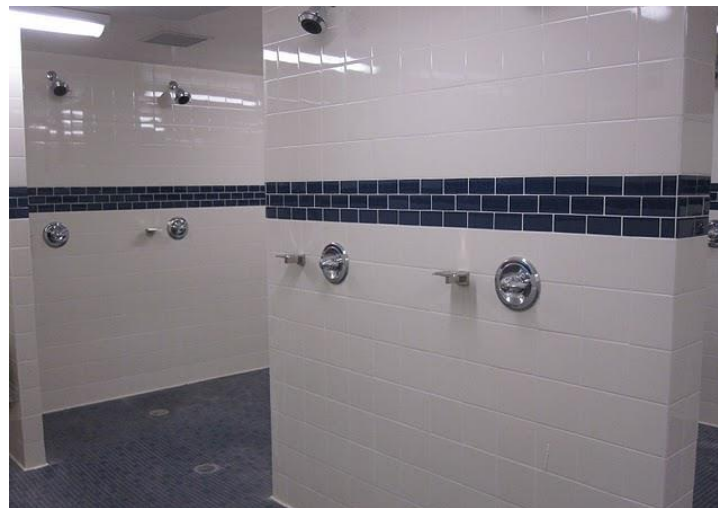
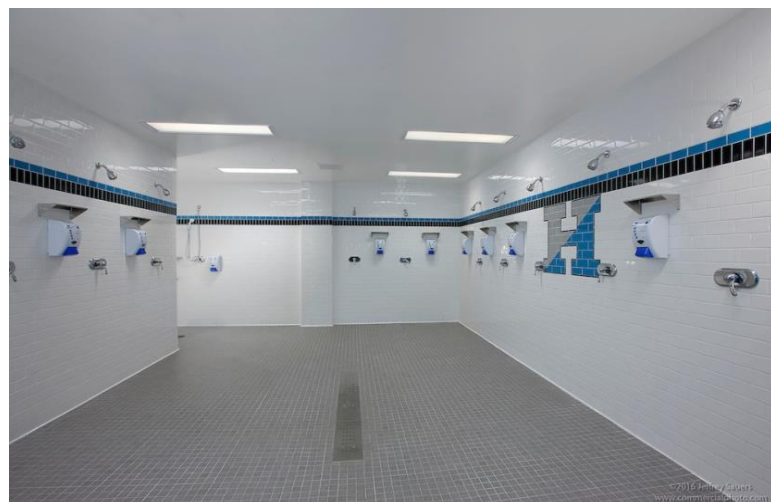
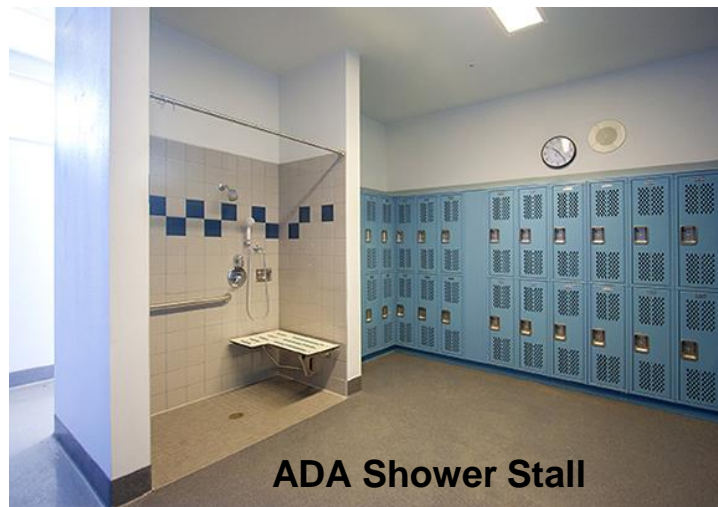
Open Showers and  
ADA Shower Stalls

- Well-lit and inviting
- Durable, easy-to-clean, non-slip ceramic tile flooring
- Recessed continuous shelf for placement of toiletries off of the floor

ADA Shower Stall

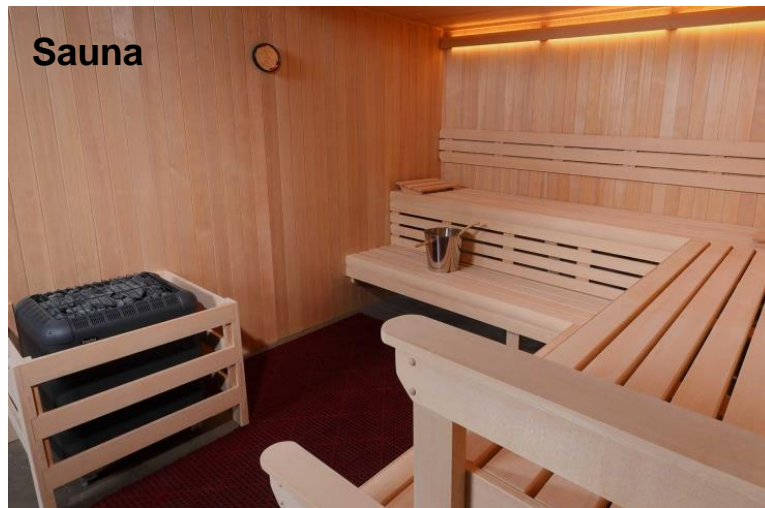
**Sauna**

- 175 – 200 degrees Fahrenheit
- Rocks are heated over an electric or wood stove warming the room.

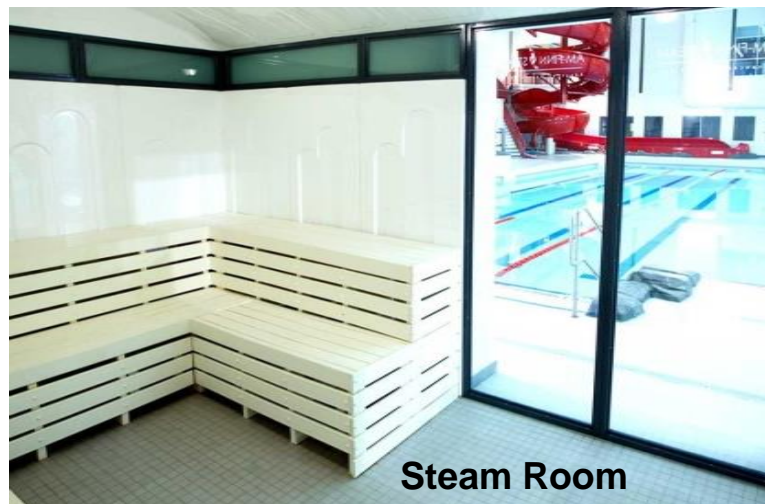
**Steam Room**

- 100 – 130 degrees Fahrenheit
- Steam generator heats water into vapor.
- Location at north pool deck with glazing in walls & door provides improved safety and supervision, space will be coed.

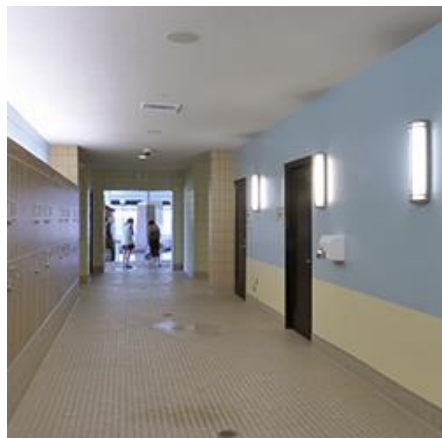
**Access Corridor**

- Access Corridor allowing visitors to flow from the Lobby to the Pool areas without passing through Locker Rooms (concept photo at upper left).
- Swimsuit dryers and baby changing stations at Locker Rooms.
- Family Changing rooms, ADA-compliant, each with its own sink, toilet, shower, bench, and baby changing station (concept photo at upper right).
- North Pool deck showers/rinse stations and updated North Pool Observation area.
